1989 Ford Truck F 250 4WD Pickup V8-445 7.3L DSL

M/T - Clutch Fluid Leaks/Incomplete Release

Article No. 90-16-7

^ CRACKS - DASH (ENGINE COMPARTMENT BULKHEAD) - [CLUTCH MASTER CYLINDER AREA](#) - VEHICLES BUILT BEFORE 6/15/90

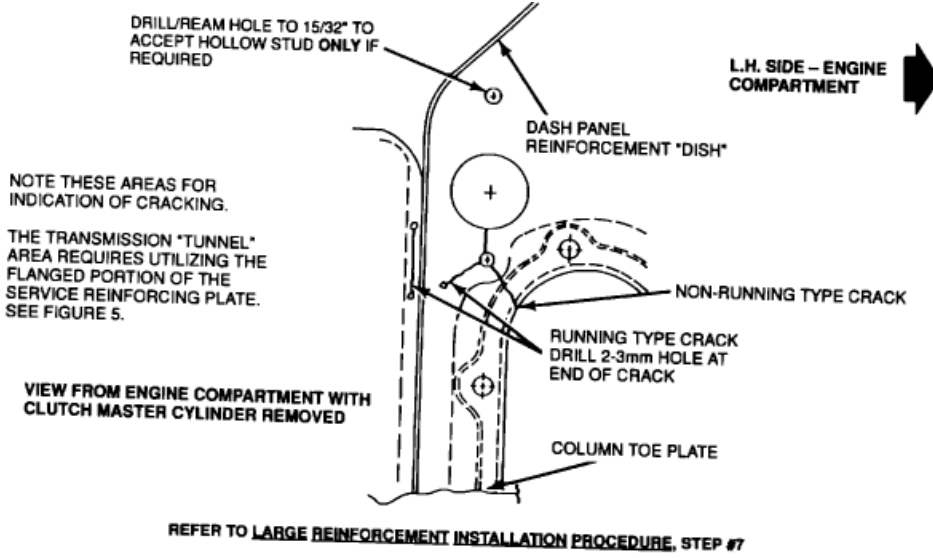
Figure 8

- c. Loosen the two (2) fasteners attaching the brake and clutch pedal support to the Y-brace, Figure 4.
7. Check for cracks.
 - a. Pull back the floor covering and dash sound insulator. (it may be helpful to remove the accelerator pedal.)
 - b. Inspect the area for pulled welds and torn dash sheet metal.

- c. If there are cracks that have not run out, stop them by drilling a 2-3 mm hole at the end, Figure 8.
NOTE: WELDING OR BRAZING IS NOT RECOMMENDED, BECAUSE IT COULD BE A SOURCE OF FUTURE BLIND SIDE CORROSION.
