Vehicle Control Unit (VCU) for the HMMWV

Background of HMMWV Starting Problems

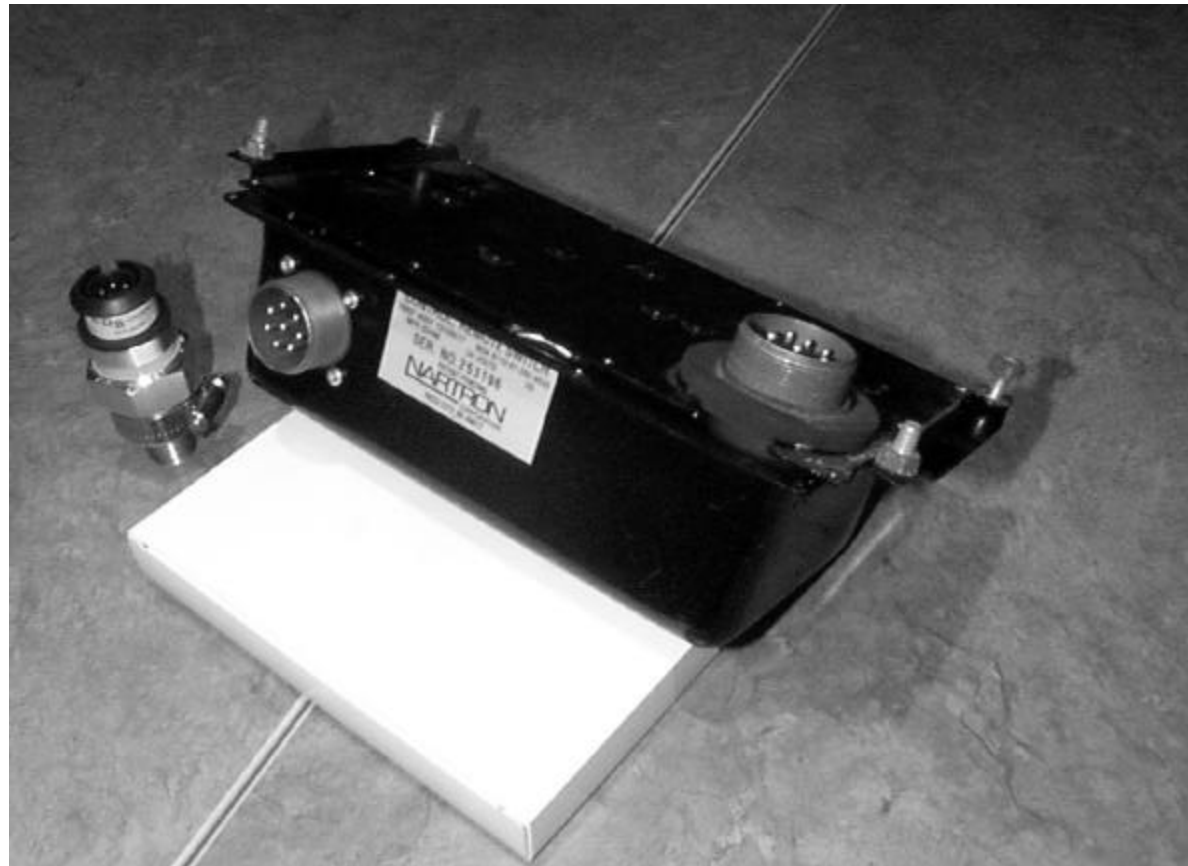
Obsolete PCB & GPC

- **Most Failed Item** in the Army's Inventory:
 - **25,000 PCBs Failed** Every Year (\$150/Box)
- **PCB Failures Caused:**
 - **480,000 Glow Plugs** to Fail Every Year (\$4.50/Plug)
 - **72,000 Glow Plug Controllers (GPC)** to be Replaced Every Year (\$45/Controller)
