1989 Ford Truck F 250 4WD Pickup V8-445 7.3L DSL

M/T - Clutch Fluid Leaks/Incomplete Release

Article No. 90-16-7

^ CRACKS - DASH (ENGINE COMPARTMENT BULKHEAD) - [CLUTCH MASTER CYLINDER AREA](#) - VEHICLES BUILT BEFORE 6/15/90

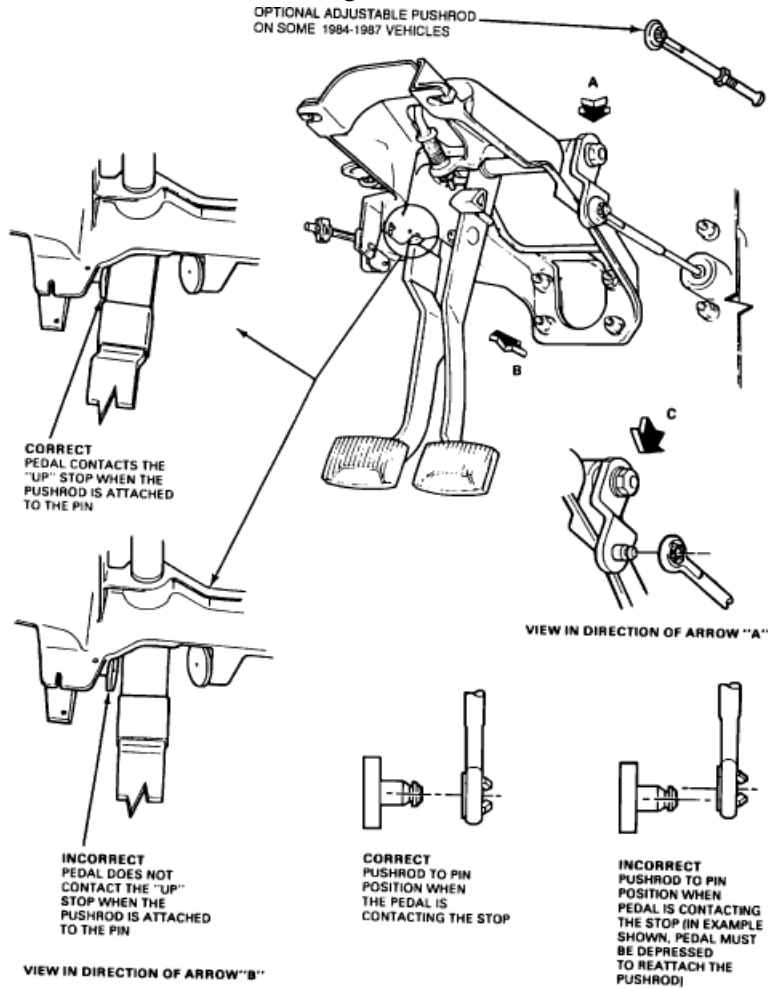
Figure 1

REFER TO INSPECTION PROCEDURE, STEP #6, AND LARGE REINFORCEMENT INSTALLATION PROCEDURE, STEP #2

- c. Pull the dash insulation back out of the way.
 - d. Disconnect the battery ground cable.
2. Disconnect the [clutch master cylinder](#) pushrod from the lever, removing the pushrod retention clip on older models, Figure 1.

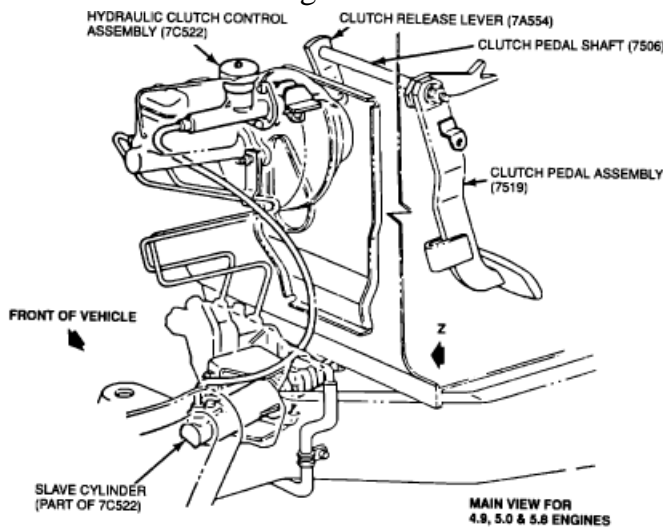
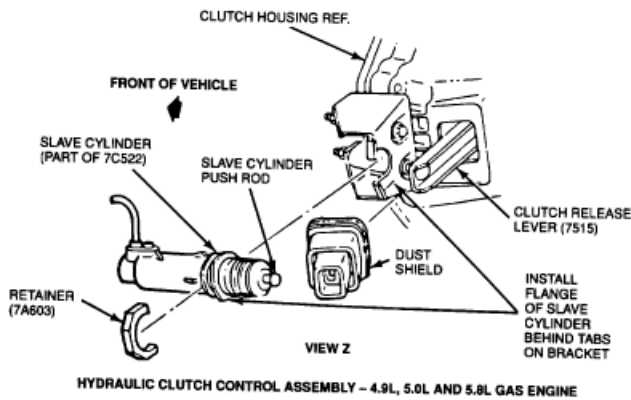
Figure 11

REFER TO SUGGESTED BLEEDING PROCEDURE
EXTERNAL SLAVE CYLINDER, STEP #3

1. Remove the master cylinder reservoir cap and diaphragm.
2. Check the fluid level to be sure it is at the step diameter of the reservoir. Do not over fill.
3. From below the truck, push the release lever slowly towards the front of the truck several times. Figures 11 & 12.
4. If it will not move, the master cylinder pushrod is not set correctly. See repair Step # 19.
5. Check the fluid level and replace the diaphragm and cap.

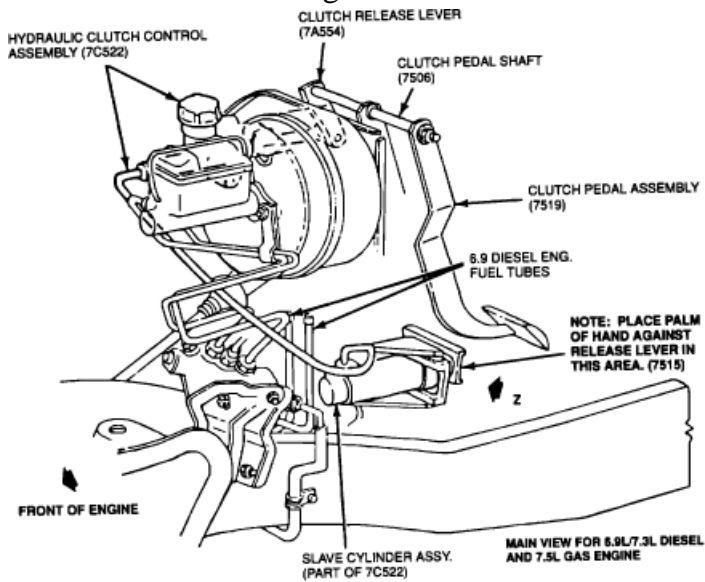
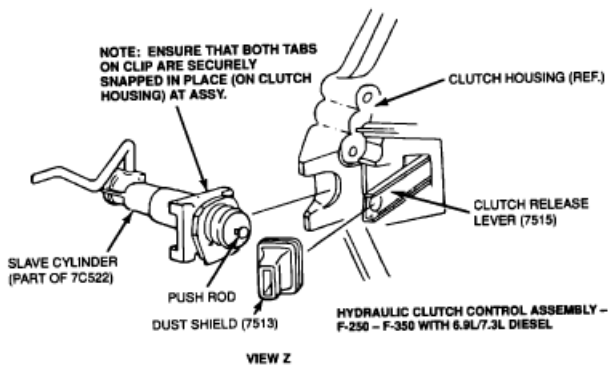
Figure 12

REFER TO SUGGESTED BLEEDING PROCEDURE - EXTERNAL SLAVE CYLINDER, STEP #3

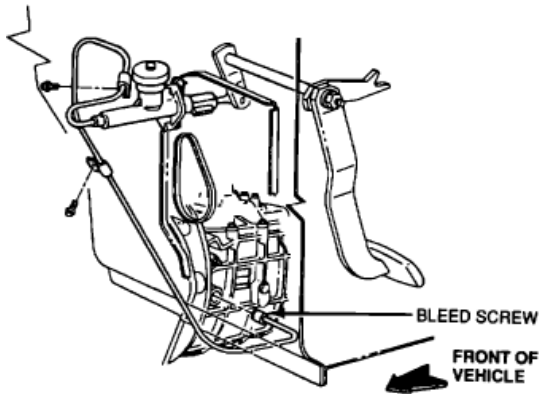
Figure 13

1988 AND LATER MODELS WITH INTERNAL CLUTCH
CONCENTRIC SLAVE CYLINDER
4.9L/5.0L/5.8L ENGINES

REFER TO SUGGESTED BLEEDING PROCEDURE -
INTERNAL CONCENTRIC SLAVE CYLINDER, STEP #8

1. Operate the clutch pedal at full stroke, 10-20 times.
2. Check the fluid level at the change in diameter part of the reservoir. Do not over fill.
3. Have an assistant depress the clutch pedal slowly and hold it down.
4. Open the slave cylinder bleed screw and watch for escaping air, Figure 13.
5. Close the bleed screw and have the assistant release pedal.
6. Repeat this cycle several times until there is no sign of air. Be sure to keep the reservoir topped to the correct level.
7. Replace the diaphragm and reservoir cover.
