Vehicle Control Unit (VCU) for the HMMWV

Background of HMMWV Starting Problems

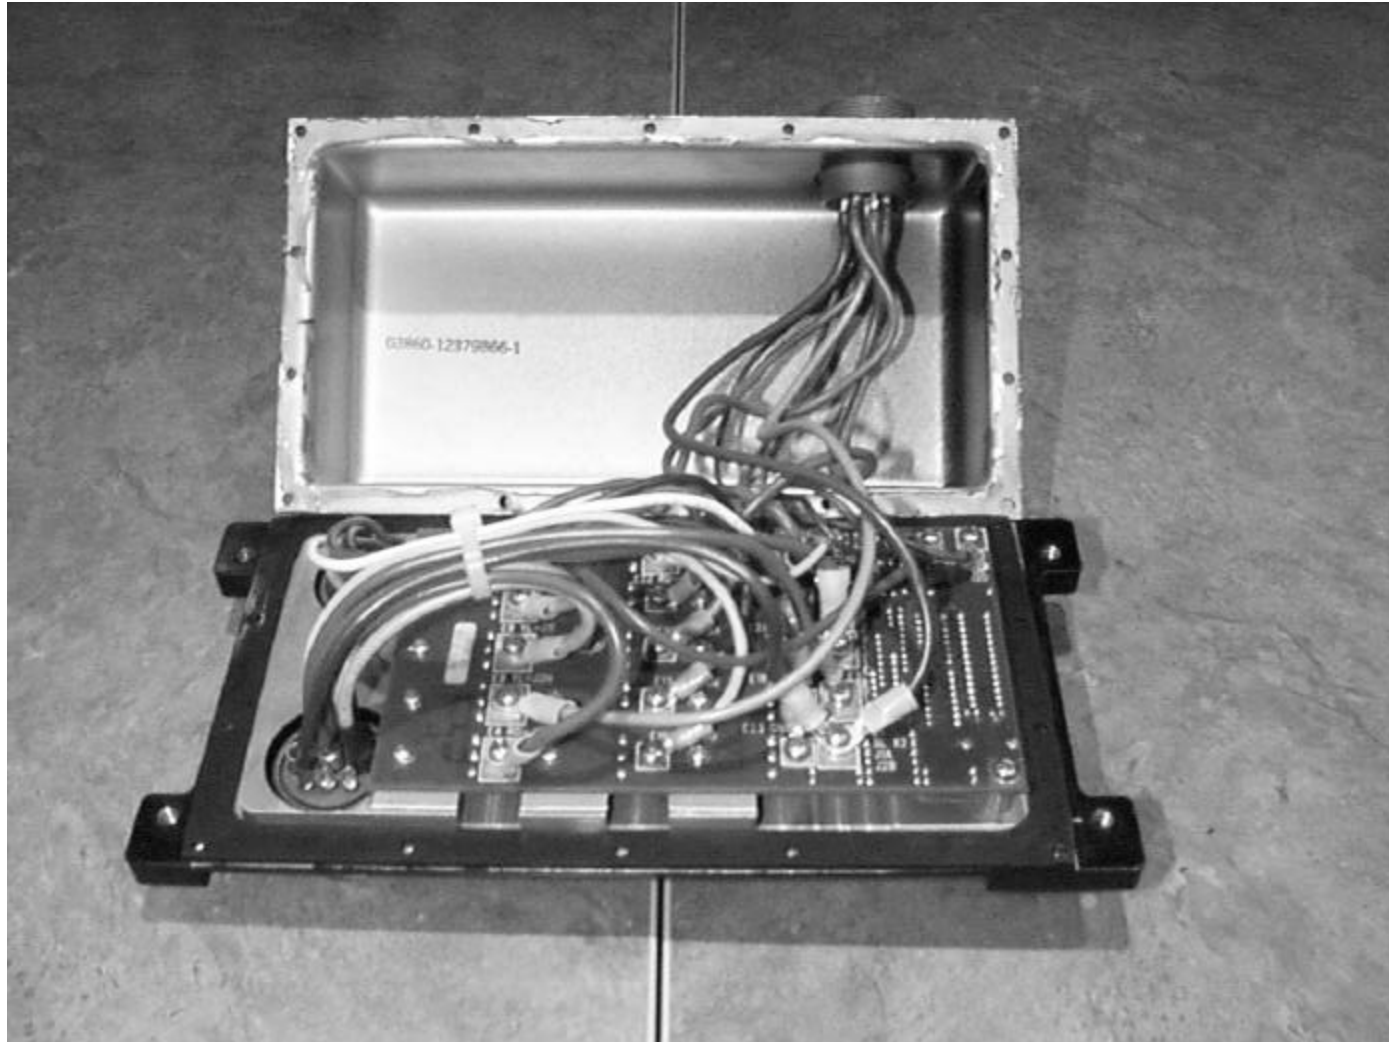
VCU - Interior View

- **GPC and PCB Functions Integrated Into one Box.**
- **True Microprocessor Control of all Functions Enables:**
 - **Precise Control of Power to Glow Plugs**
- **All PCB Relays Eliminated - Replaced by Ultra-High-Current Power MOSFETs.**
- **Multi-Channel Glow Plug Operation Enables:**
 - **Starting with Multiple Glow Plug Failures (Previously Impossible with old PCB System).**
 - **Simplified Glow Plug Troubleshooting/Diagnostics.**
