ZF Industries

DESCRIPTION AND OPERATION

The model number for the ZF transmission (7003) is S5-42. This model number can be divided into three parts. First, "S" designates a synchronized transmission. Second, "5" designates the number of forward gears. Finally, "42" is the approximate maximum input torque capacity in tens of ft-lb. In this case 42 equals 420 ft-lb. input torque capacity.

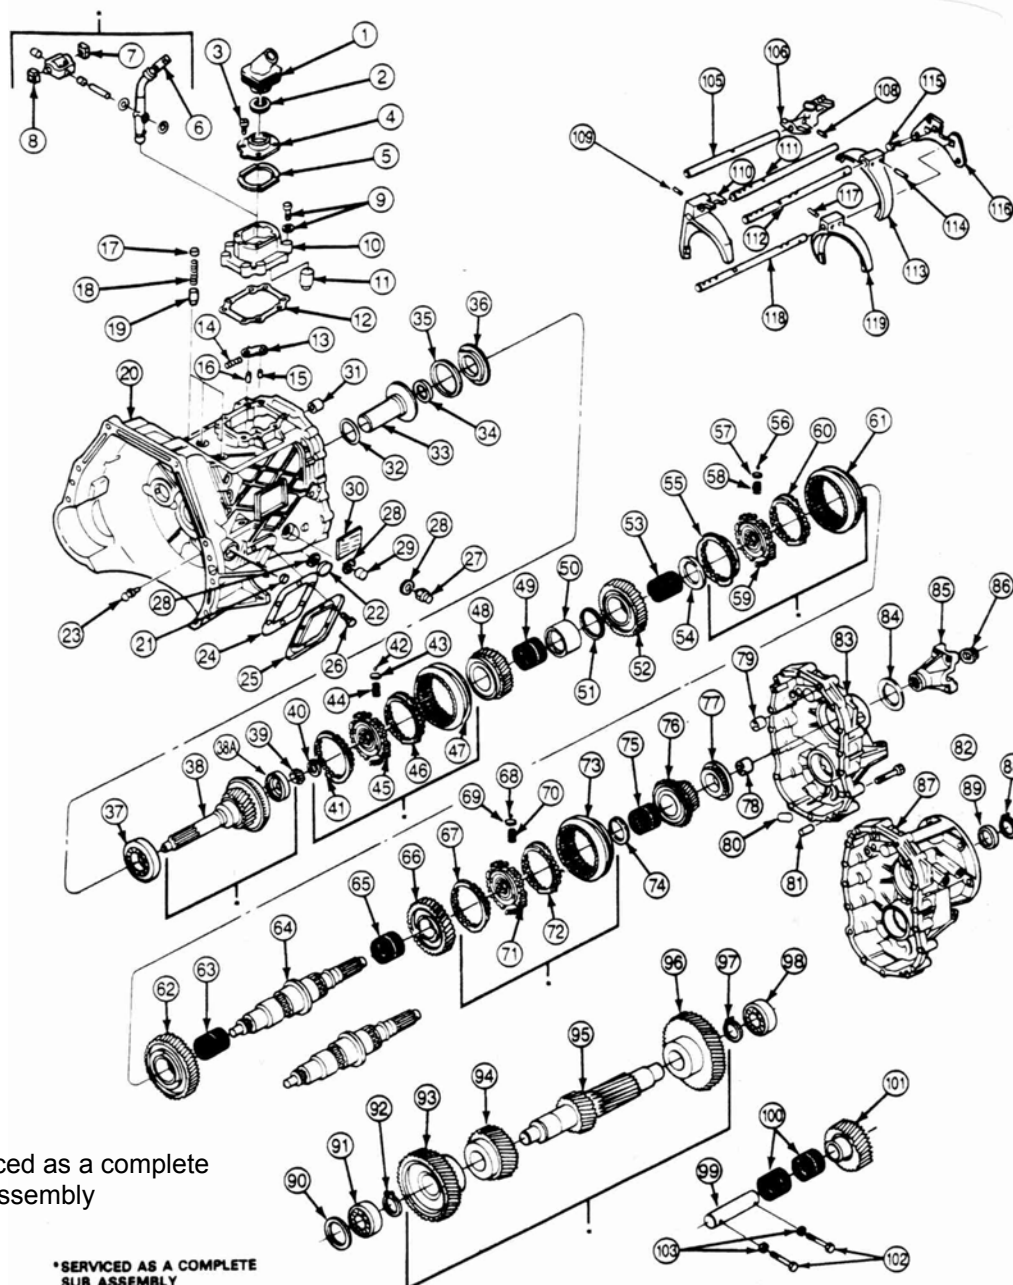
Model S5-

* Serviced as a complete sub assembly

*SERVICED AS A COMPLETE SUB ASSEMBLY

Item	Part Number	Description
37	7025	Case Bearing
38	7017	Input Shaft
38A	7046	Front Bearing Oil Scoop Ring
39	7120	Input Shaft Pocket Ring
40	7B331	Small Parts Repair Kit
41	—	Gear Synchronizer Ring (Part of 7124)
42	—	Ball (Part of 7B331)
43	7124	Synchronizer
44	—	Spring (Part of 7B331)
45	—	3rd Gear Synchronizer Body (Part of 7124)
46	—	3rd Gear Synchronizer Ring (Part of 7124)
47	—	3rd-4th Sliding Sleeve (Part of 7124)
48	7186	3rd Gear
49	7133	Caged Needle Roller Bearing
50	7173	3rd Speed Bearing Spacer
51	7114	Thrust Washer
52	7103	2nd Gear
53	7133	1st Speed Gear Bearing
54	7B331	Small Parts Repair Kit
55	7124	2nd Gear Synchronizer Ring
56	7124	Ball
57	7124	Pressure Piece
58	7124	Spring
59	7124	1st-2nd Synchronizer Body
60	7124	1st Gear Synchronizer Ring
61	7124	1st-2nd Sliding Sleeve
62	7100	1st Gear
63	7127	3rd Gear Bearing
64	7061	Mainshaft
65	7127	Reverse Gear Bearing
66	7142	Output Shaft Reverse Gear
67	7124	Reverse Gear Synchronizer Ring

Item	Part Number	Description
71	7124	5th-Reverse Synchronizer Body
72	7124	5th Gear Synchronizer Ring
73	7124	5th-Reverse Sliding Sleeve
74	7B331	Small Parts Repair Kit
75	7121	5th Gear Bearing
76	7158	5th Gear
77	7R205	Output Shaft Rear Bearing
78	7072	Spacer
79	7D362	Central Shift Rail Bearing
80	7E290	Magnet
81	—	Dowel (Part of 7003)
82	7A443	Bolt
83	7A039	Extension Housing (4X2)
84	7052	Input Shaft and extension Housing Seal
85	7089	Output Yoke (4X2)
86	7045	Output Yoke Locknut (4X2)
87	7A039	Extension Housing (4X4)
88	7B331	Small Parts Repair Kit
89	7052	Input Shaft and Extension Housing Seal
90	7119	Thrust Washer
91	7065	Output Shaft Bearing
92	7064	Output Shaft Snap Ring
93	7113	Countershaft Drive Gear
94	7113	Countershaft 3rd Gear
95	7113	Countershaft Cluster Gear
96	7113	Countershaft 5th Gear
97	7064	Output Shaft Snap Ring
98	7065	Output Shaft Bearing
99	7140	Reverse Idler Gear Shaft
100	7E139	Reverse Idler Gear Bearing
